Learning from history:

Lessons from past accidents 1981-2017

Produced by *RAIL* magazine

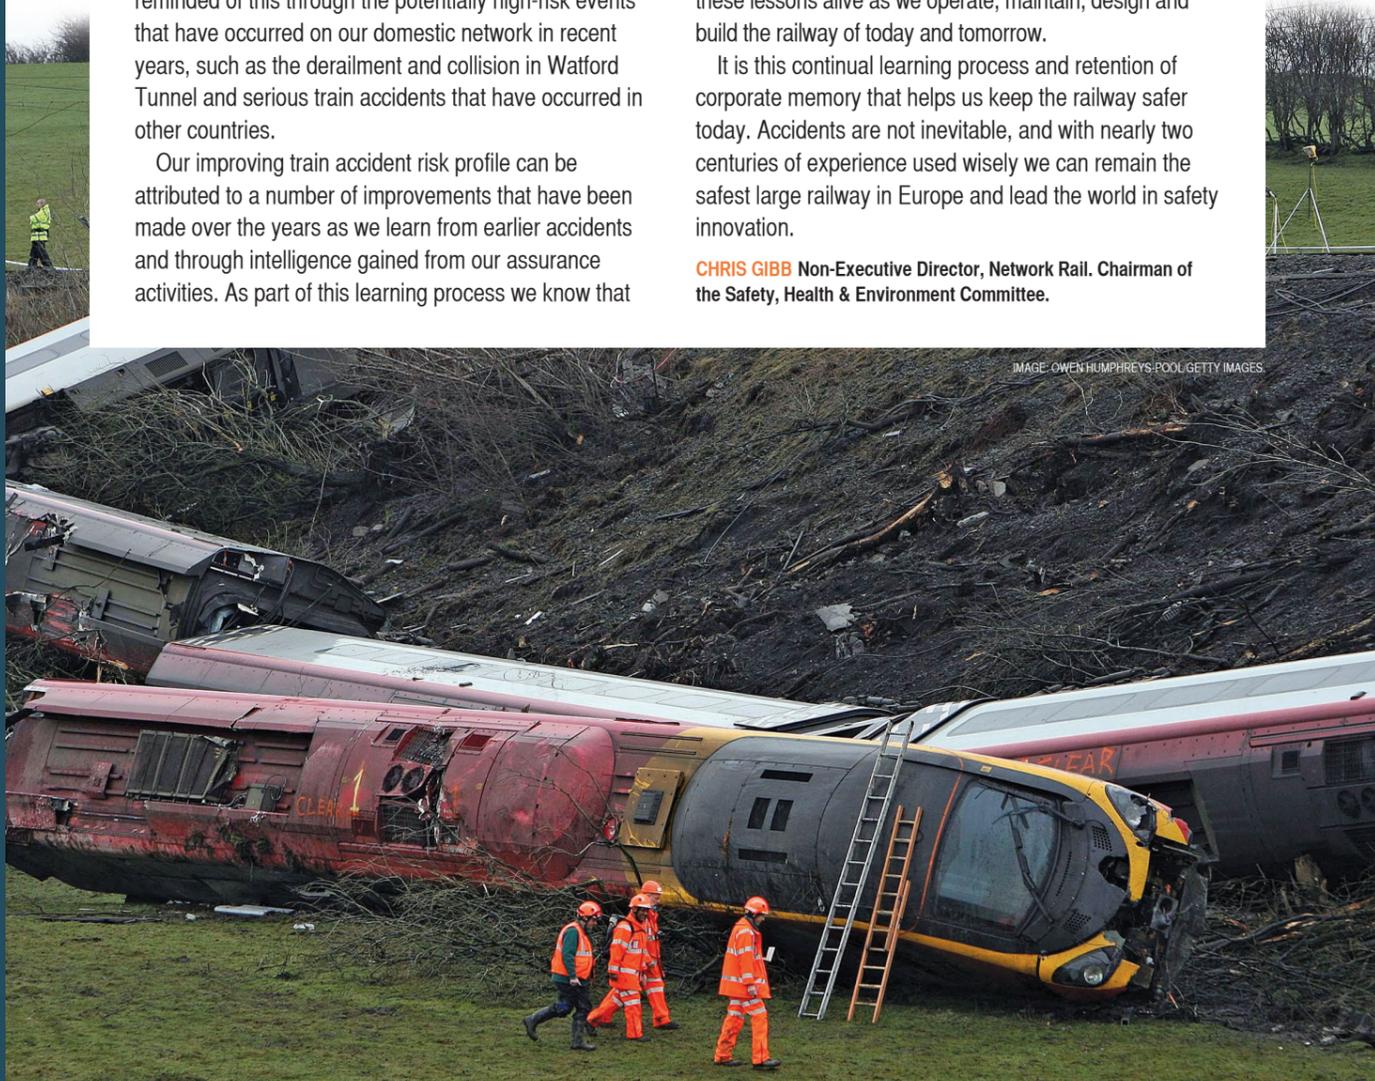
Just before 20.15hrs on February 23 2007, a Pendolino carrying 109 passengers and crew derailed at 95mph near Grayrigg in Cumbria (pictured, left). All nine vehicles left the line; eight jack-knifed down an embankment. One person was killed - 84-year-old Margaret Masson; 28 more suffered serious injury, including the train driver.

Both the rail industry and Rail Accident Investigation Branch (RAIB) investigations confirmed that the train derailed on a crossover, the immediate cause being the condition of the pointwork. The train itself, however, was widely praised: its crashworthiness serving to minimise the harm to all those on-board.

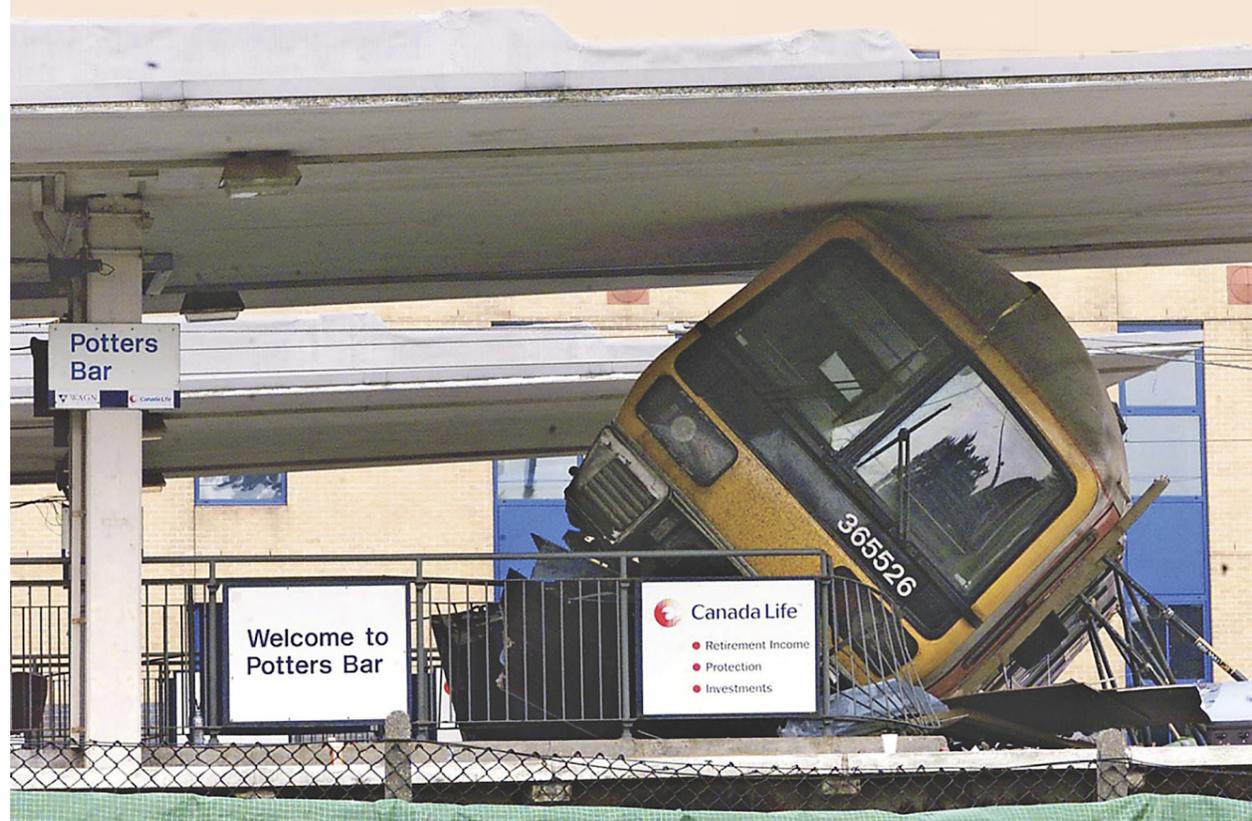
On May 10 2002, a Class 365 EMU derailed, killing seven people and injuring 76. The train crossed over a set of points at 97mph, which moved, causing the rear bogie of the third carriage and the whole of the fourth carriage to derail. The accident at Potters Bar was essentially about bolts and stretcher bars. One of the former had worked loose, allowing the latter to move under the passenger train.

Below: During the accident at Potters Bar, the fourth carriage became detached, crossed onto the adjacent line, flipped into the air and landed in the station under the platform canopy. SEAN DEMPSEY/PA IMAGES.

time. Potters Bar contributed to Network Rail deciding to bring all track maintenance in-house from 2003 - a move that allowed the company to take a more strategic approach to the way the infrastructure is managed.

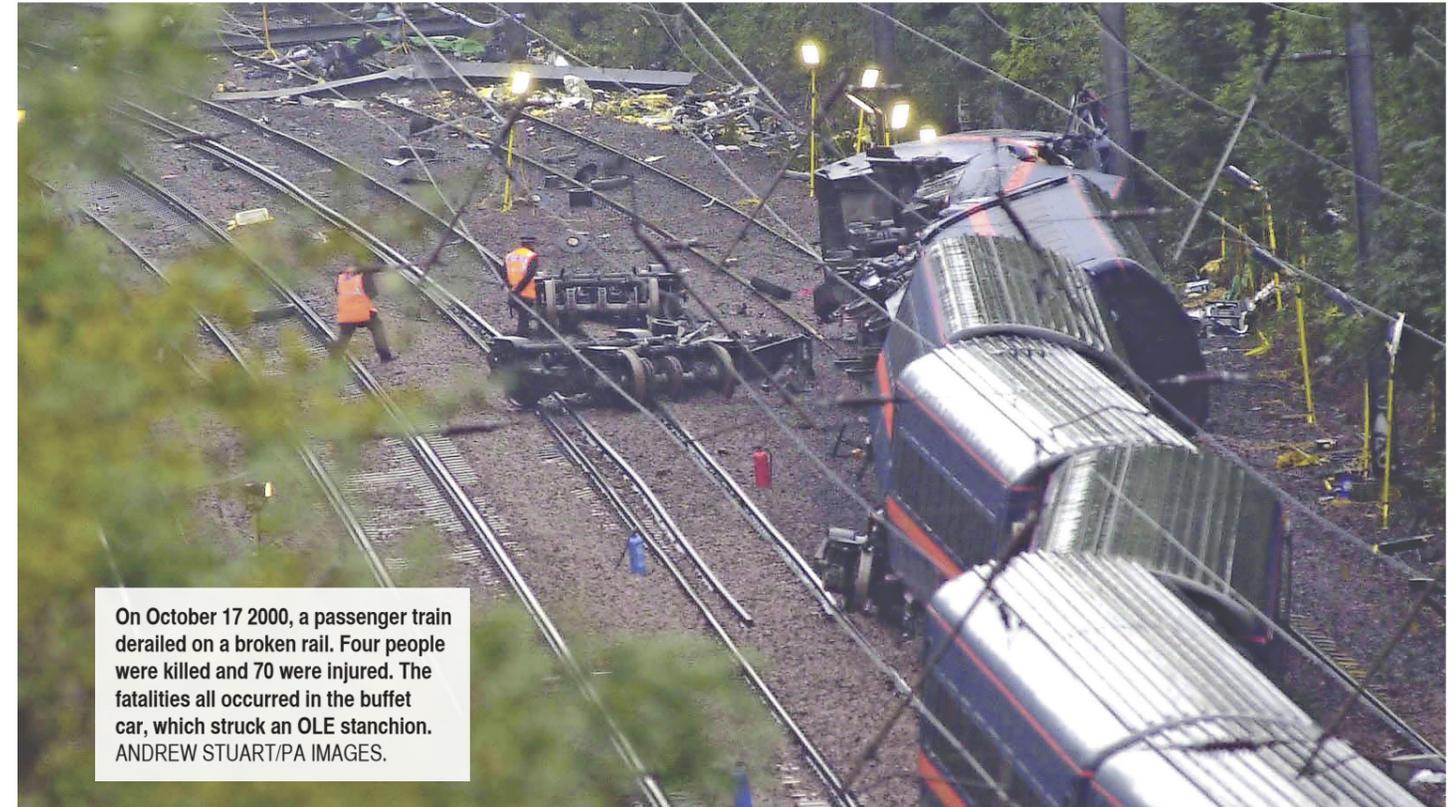
On October 17 2000, a passenger train derailed on a broken rail. Four people were killed and 70 were injured. The fatalities all occurred in the buffet car, which struck an OLE stanchion. ANDREW STUART/PA IMAGES.

The Hatfield accident occurred when a rail, in which gauge corner cracking (GCC) had caused multiple cracks and fractures, fragmented as a high-speed train passed over it. Ironically, the HSE and the (then) Rail Regulator had already commissioned the Transport Technology Centre to investigate broken rails and their management. The resulting report was published that November, one month after the accident. It, and the Hatfield accident itself, led to the establishment of a taskforce to research metallurgy, wheel-rail interaction, brake design, suspension design, and ultrasonic rail flaw detection.

As a response to Hatfield, the industry now has a much better understanding of rail failure modes and how to manage them better through, for example, rail grinding. The technology in this area has also improved and includes the introduction of Plain Line Pattern Recognition (PLPR) and ultrasonics, combined with eddy current testing, capturing a much more accurate picture of the condition of rail in situ. Network Rail has also introduced a number of predictive tools and programmes to identify precursor events and help the track engineer with the prevention of rail defects.

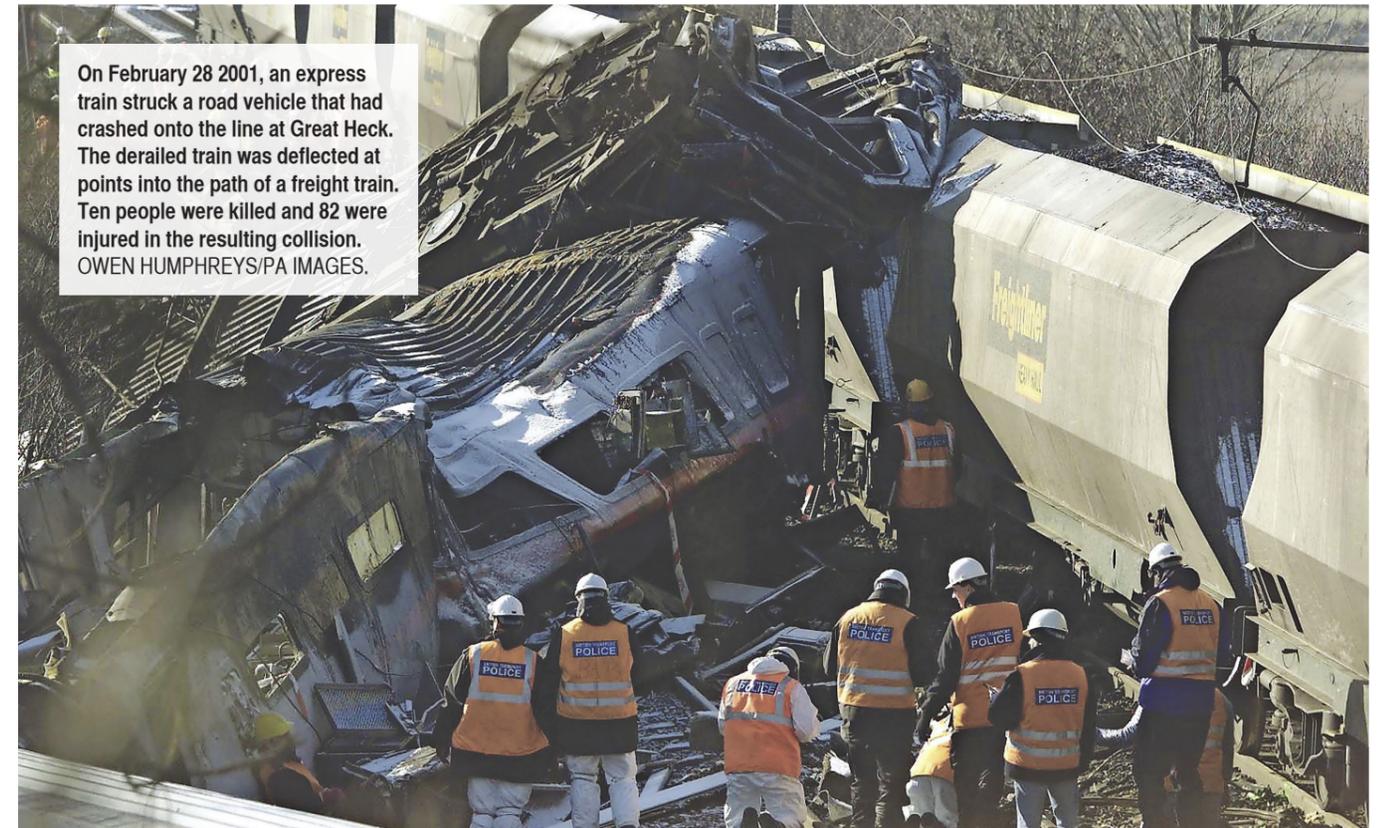
On February 28 2001, an express train struck a road vehicle that had crashed onto the line at Great Heck. The derailed train was deflected at points into the path of a freight train. Ten people were killed and 82 were injured in the resulting collision. OWEN HUMPHREYS/PA IMAGES.

The accident at Great Heck occurred after the driver of a Land Rover towing a loaded trailer fell asleep whilst driving along the M62. The vehicle swerved off the motorway, down an embankment and onto the East Coast Main Line. After failing to reverse his vehicle off the line, the driver left it and called the emergency services moments before it was struck by a train. As in the incident at Ufton, at first only the front bogie derailed, the train remaining upright for around half a mile before points to nearby sidings diverted it into the path of a freight train carrying coal.

The investigation found no failings 'in respect of health and safety legislation by the railway infrastructure controller or the train operators', but recommended that 'The Department for Transport, Local Government and the Regions (DTLR) [...] lead, with the involvement of relevant interested parties, the development of tools and data for use at local level by highway and railway professionals to carry out comparative assessments of the risks of road vehicles obstructing the railway at specific sites.'

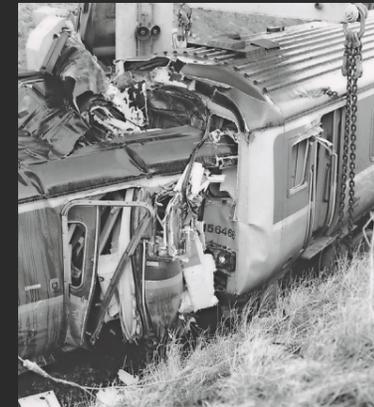
The accident at Ais Gill was relatively minor at first, occurring after a train ran into a landslide and derailed. It escalated when the respective control offices failed to respond correctly to the emergency National Radio Network (NRN) call that the injured driver was able to send immediately after the derailment.

The devastation near Ais Gill following the collision between two Class 156 units on the Settle and Carlisle Line. MALCOLM STEAD.

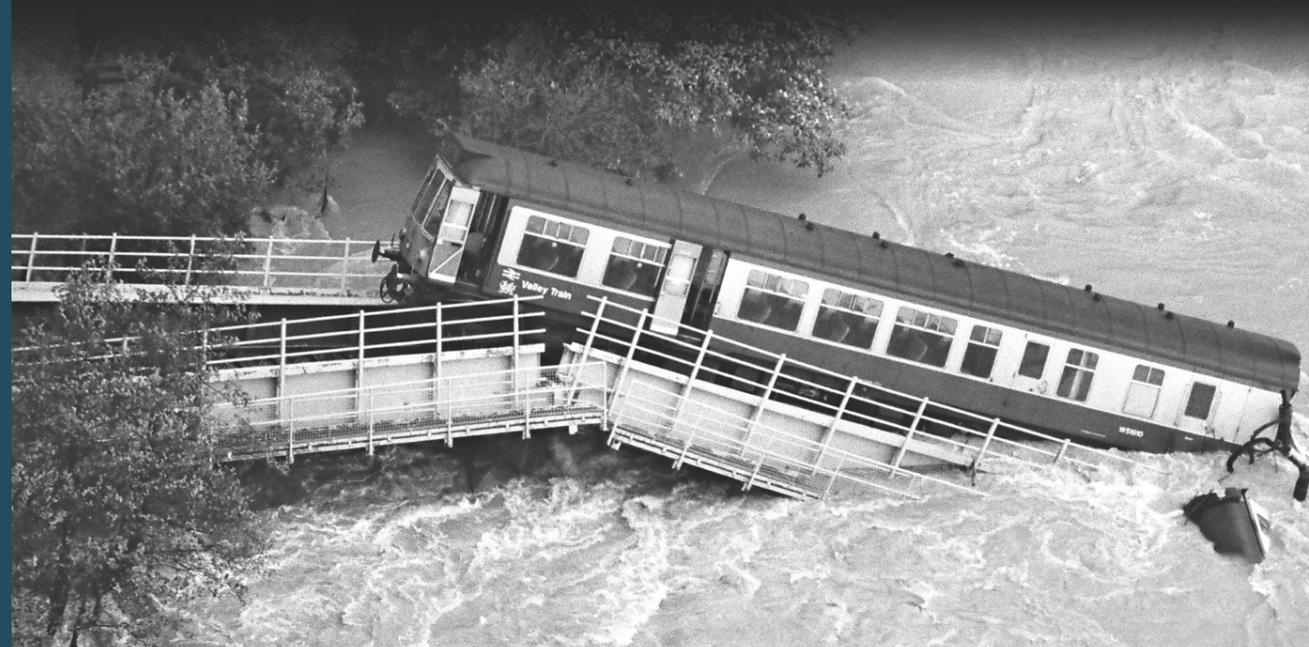
In 1987, Glanrhyd Bridge partially collapsed as a result of the River Towy swelling after many hours of heavy rainfall. The previous evening, adverse weather conditions had led to a number of reports of flooding and potential ballast wash-out on the Central Wales Line, but attempts to inspect the track visually were thwarted by local roads being blocked by those same floods. It was duly agreed that the first train in the morning would be used to examine the line.

On October 19 1987 the 0527 Swansea-Shrewsbury Class 108 DMU tumbled into the River Towy near Llandeilo after the Glanrhyd Bridge was partially washed away. Four people died. PA IMAGES.

The situation is now being addressed via a new Code of Practice for coastal, estuarine and river defences, and the sharing of best practice risk assessment methodology, weather alerts, monitoring technology and adverse weather response arrangements.

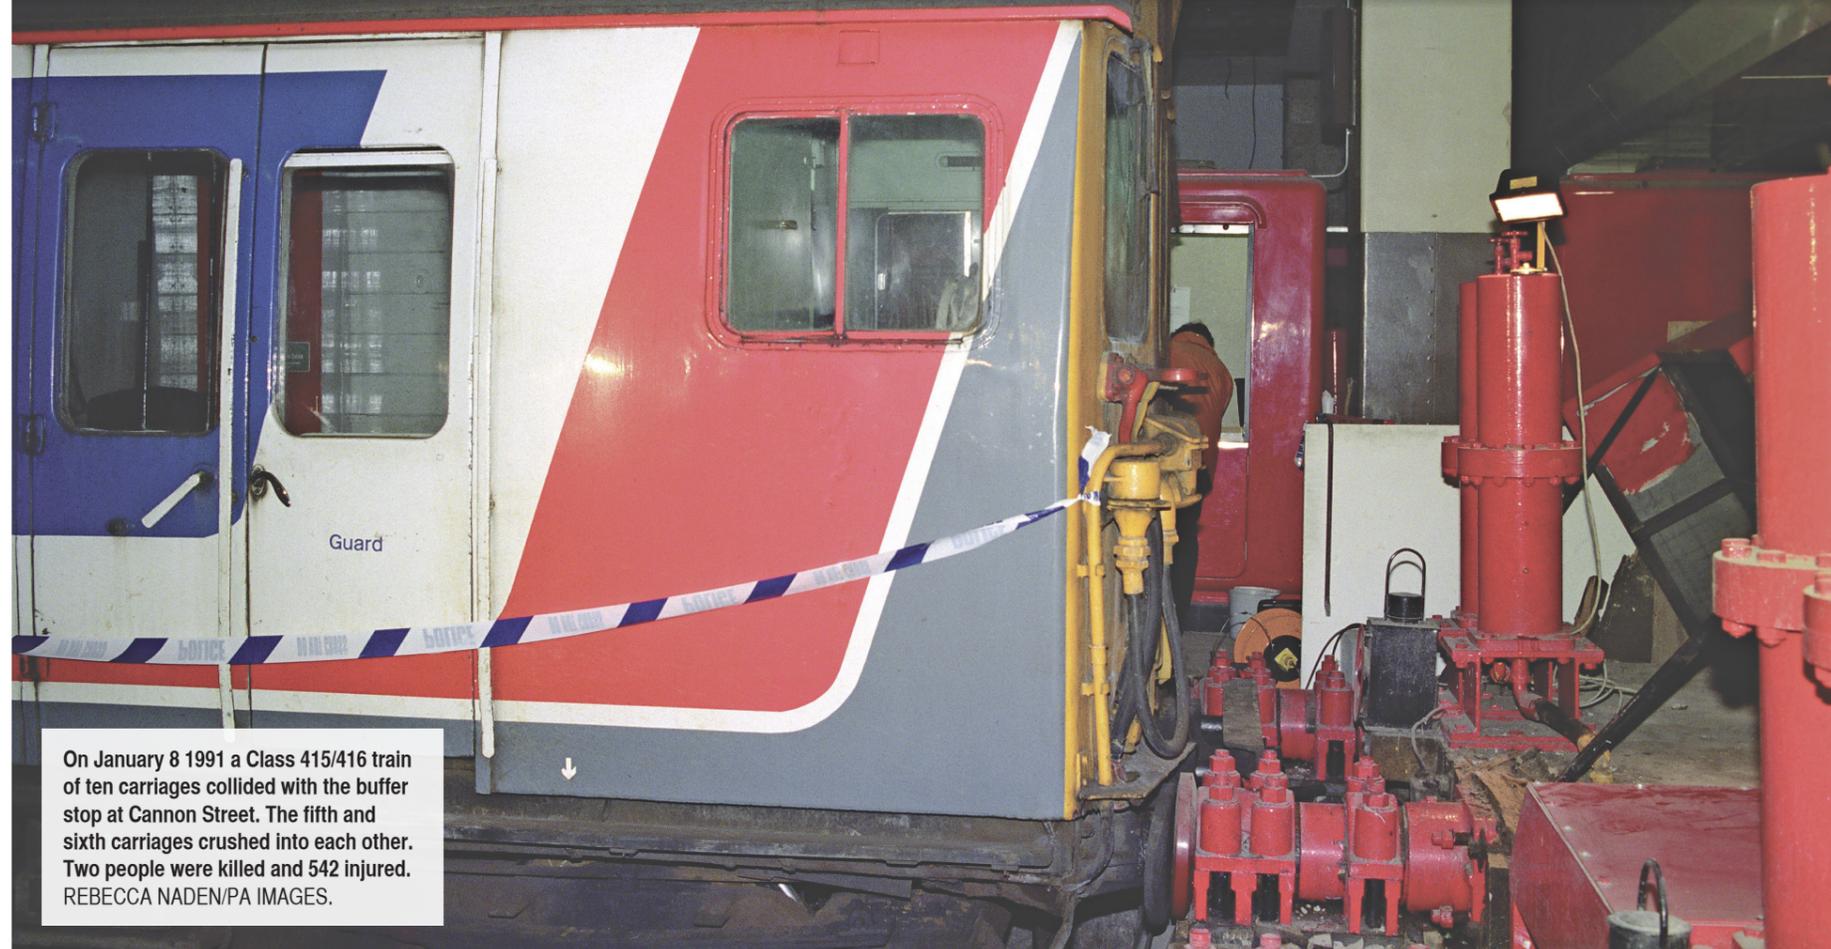
The accident at Cannon Street station occurred because the driver of an incoming train failed to control its speed sufficiently to bring it to a stand short of the buffer stops. The high number of injuries that resulted was compounded by an overcrowded train and the relative lack of crashworthiness of the ageing rolling stock.

On January 8 1991 a Class 415/416 train of ten carriages collided with the buffer stop at Cannon Street. The fifth and sixth carriages crushed into each other. Two people were killed and 542 injured. REBECCA NADEN/PA IMAGES.

New buffer stops are required to be of an energy-absorbing design and assessed for the risk arising from a train colliding with them.

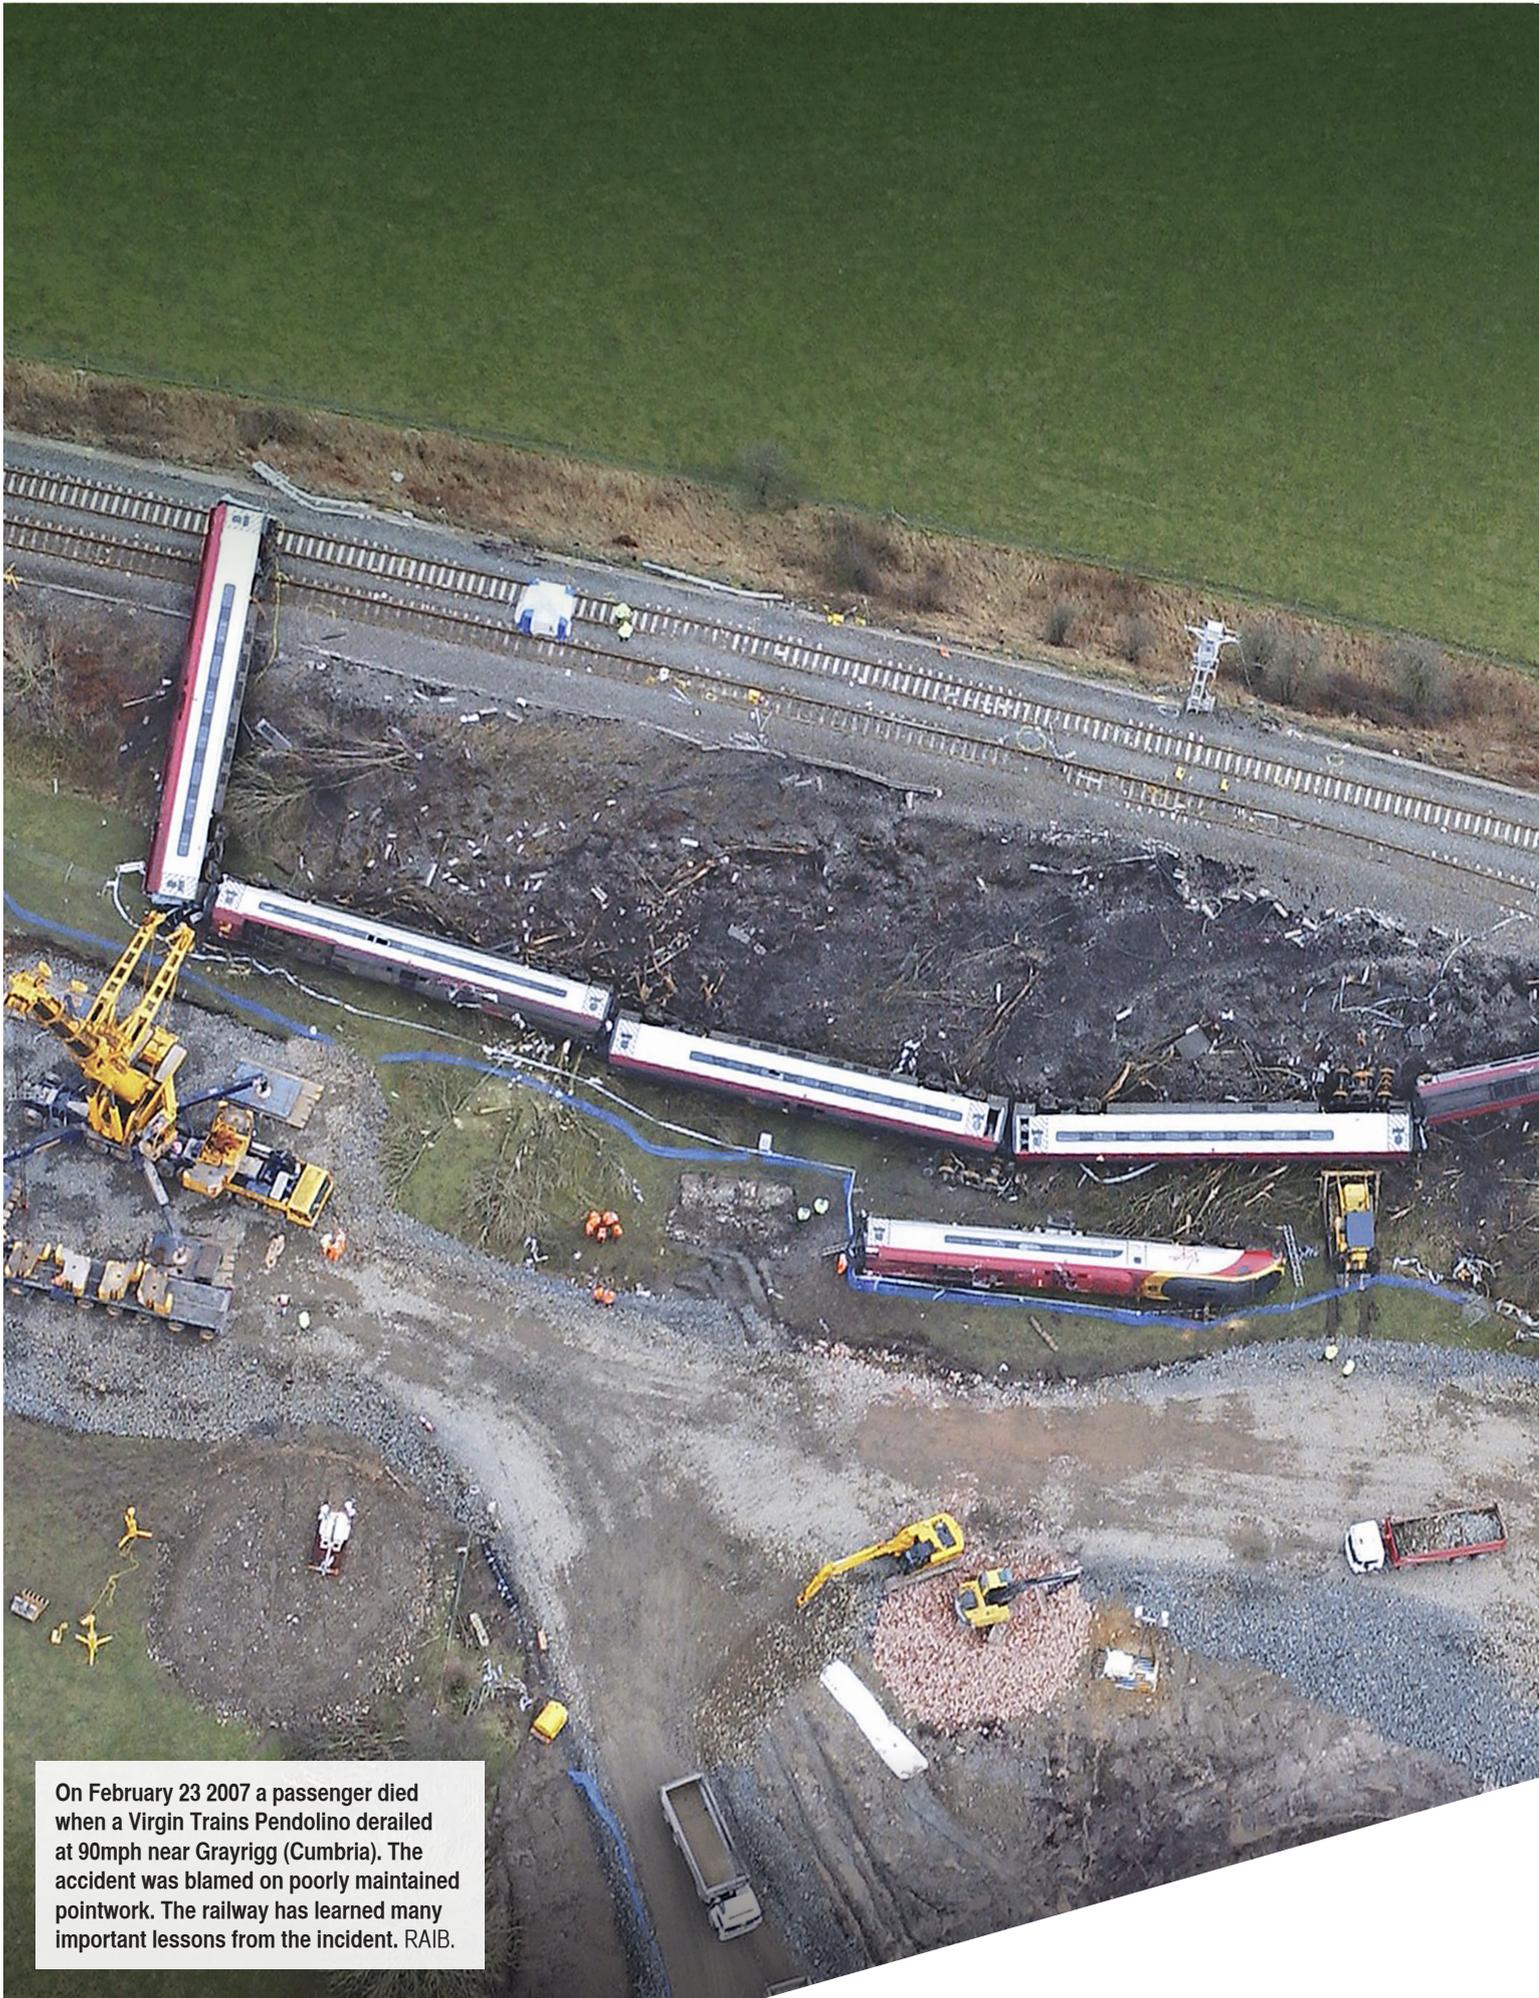
Poor maintenance was also implicated five years later, when a Class 390 Pendolino derailed on a groundframe-operated facing crossover at Grayrigg. RAIB's investigation confirmed the immediate cause to have been the condition of the stretcher bars. Between the three, one was not in position, another had nuts and bolts missing and two were fractured.

On February 23 2007 a passenger died when a Virgin Trains Pendolino derailed at 90mph near Grayrigg (Cumbria). The accident was blamed on poorly maintained pointwork. The railway has learned many important lessons from the incident. RAIB.

More fundamentally, neither fixed nor adjustable stretcher bars had ever been designed with an engineering understanding of the forces to which they would be subject. Now, a new design of tubular stretcher bar - which has designed out a number of failure modes - has been introduced.
